STUDY ON LANDSLIDES MAPPING AS A RESULT OF FLOODS IN THE PELAGONIA REGION

GAUSS Institute -
Foundation of new technologies, innovations and knowledge transfer

Bitola, December 2019

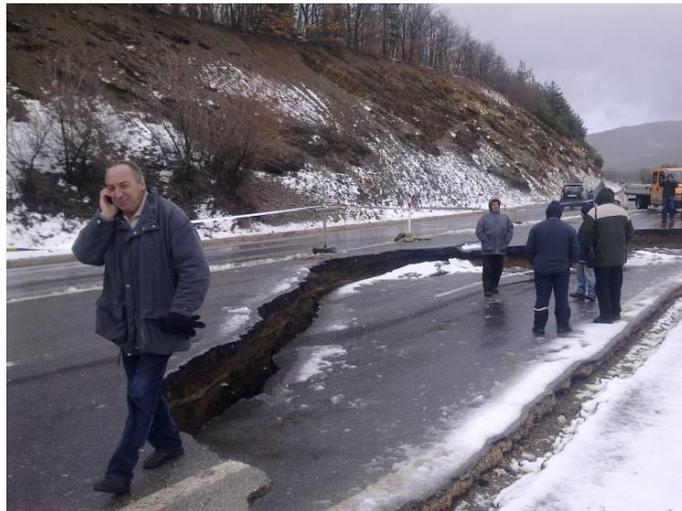
Figure 7. Frontal landslide fracture on 21.02.2010 with visible jump of about 0.6 meters and detachment of about 0.1 meters

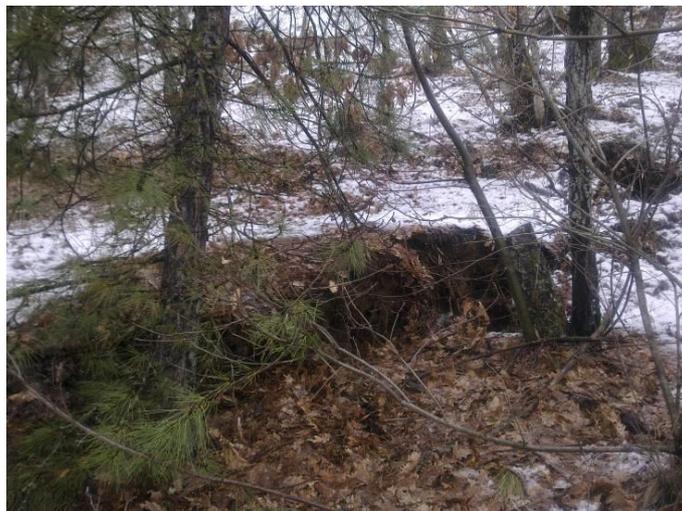
Figure 8. Secondary landslide fracture on 21.02.2010

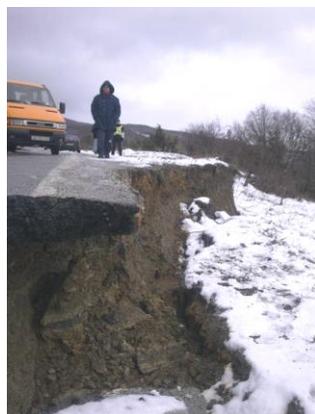
Figure 9. Condition of frontal fracture with jump over one meter on 22.02.2010

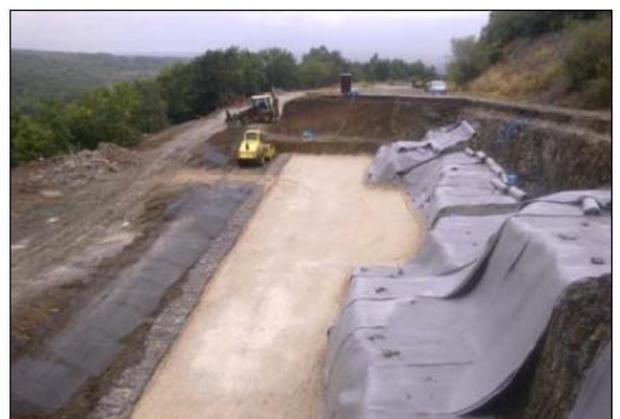
Figure 10. Landscape Reconstruction Phase general view (2011)

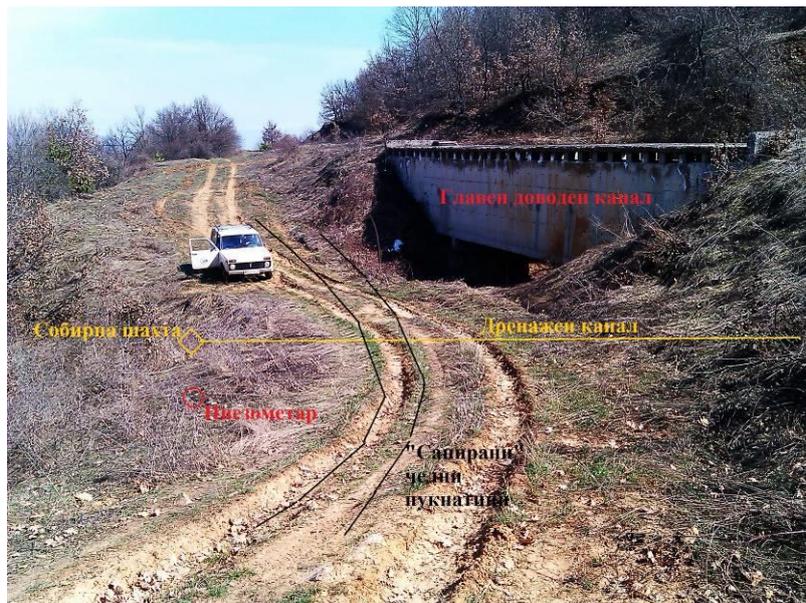
This landslide has been treated in the past, i.e. site investigations have been carried out. At this stage, 3 piezometers have been incorporated, but no measurements have been made so far, so there is insufficient knowledge of any improvements or stabilizations on the terrain. The landslide forehead (frontal cracks) were recorded on the access road next to the main supply channel (Figure 12), but were temporarily repaired (leveled and filled) for the purpose of enabling the road to function. During partial repair of the landslide, a drainage pipe was incorporated to collect the waters near the channel and take them to the collecting manhole (Figure 13).

Figure 13. Current state of the landslide (source: photographed 29.03.2012)

From the inspections and consultations with the representatives of PE "Strezhevo" regarding the condition of the main water supply channel, it can be concluded that the landslide is currently in a stable condition, but not all measures for its final (permanent) stabilization have been undertaken.

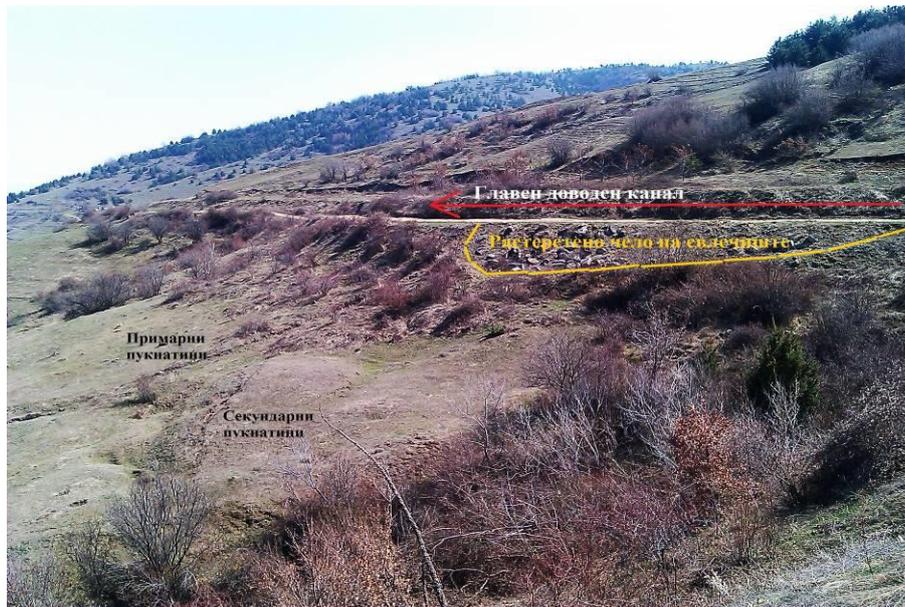
In this landslide during the exploitation phase of the channel, and also on the access road, a frontal crack appeared directly next to the road. For that purpose, the landslide forehead was loose to stabilize the access road, which is currently in stable condition (Figure 16). During the on-site inspection, the primary landslide cracks were noted which occurred in the first phase of the landslide, and the secondary cracks that occurred later in the past, thus defining the nature of the landslide and concluding that the landslide is currently in a “standby” phase (figure 17). During the inspection of the interior of the channel, it was noticed that there is a large segregated areas on the left side of the channel.

Figure 17. Current state of the landslide (photo 29.03.2012)

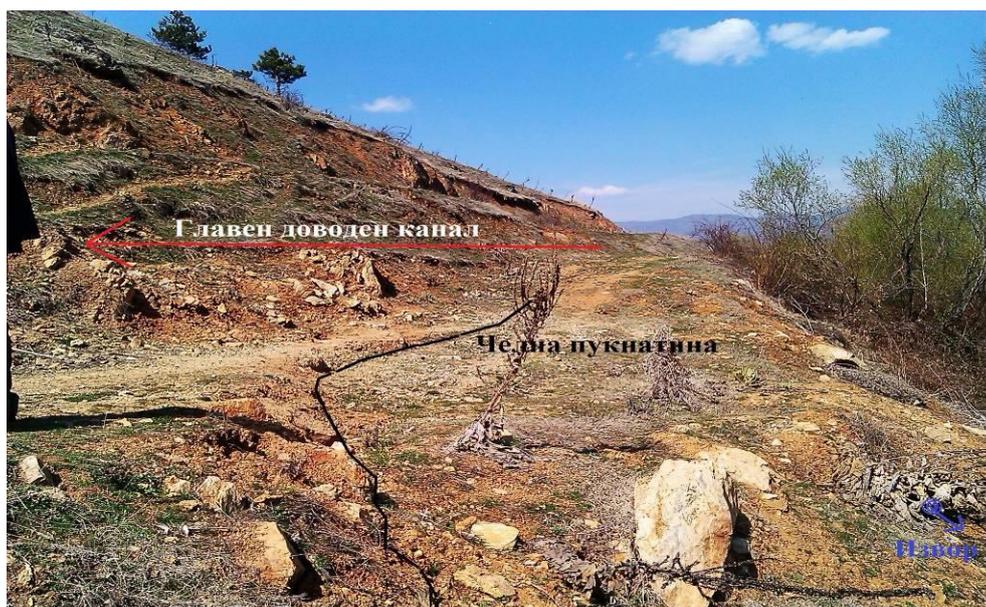
This landslide is located near the village of Kukurechani (Figure 18). The frontal crack of 35 cm is descending to the middle of the access road (Figures 19 and 20). In the immediate vicinity there is a spring whose waters are thought to be part of the water passing through the channel. This is supported by the data obtained during inspections inside the channel, which revealed that there is a large segregation of surfaces on both sides of the channel with longitudinal cracks in the crown and at the bottom of the channel. Figure 21 shows the curvature of the vegetation - a drunk forest which is another indicator of terrain movement.

Figure 19. Current status of the landslide (photographed 29.03.2012)

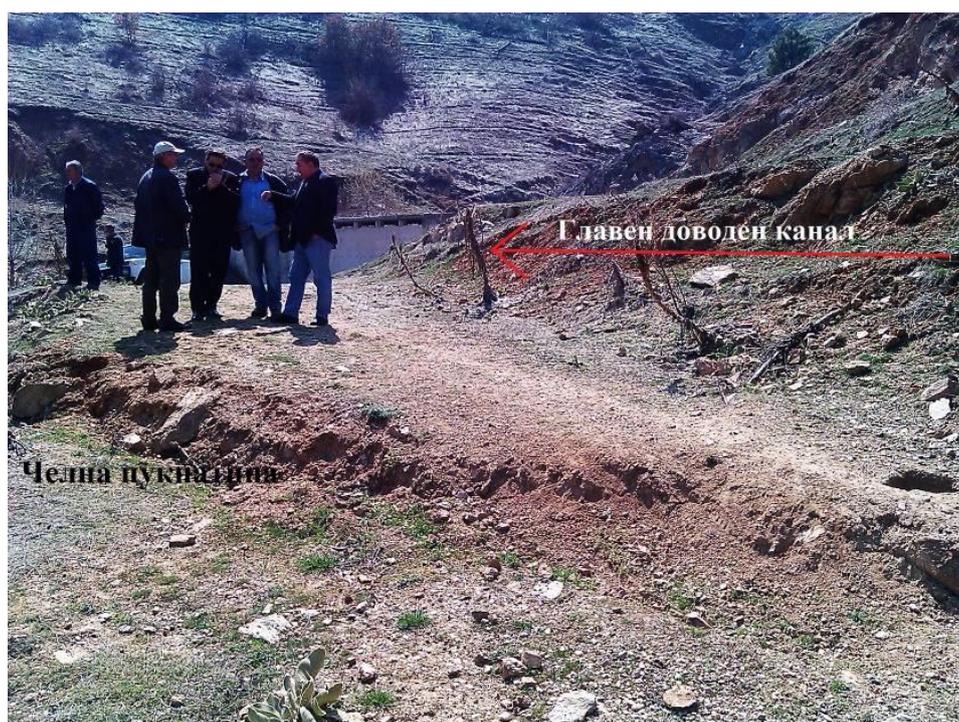
Figure 20. Current state of the landslide (source: photographed 29.03.2012)

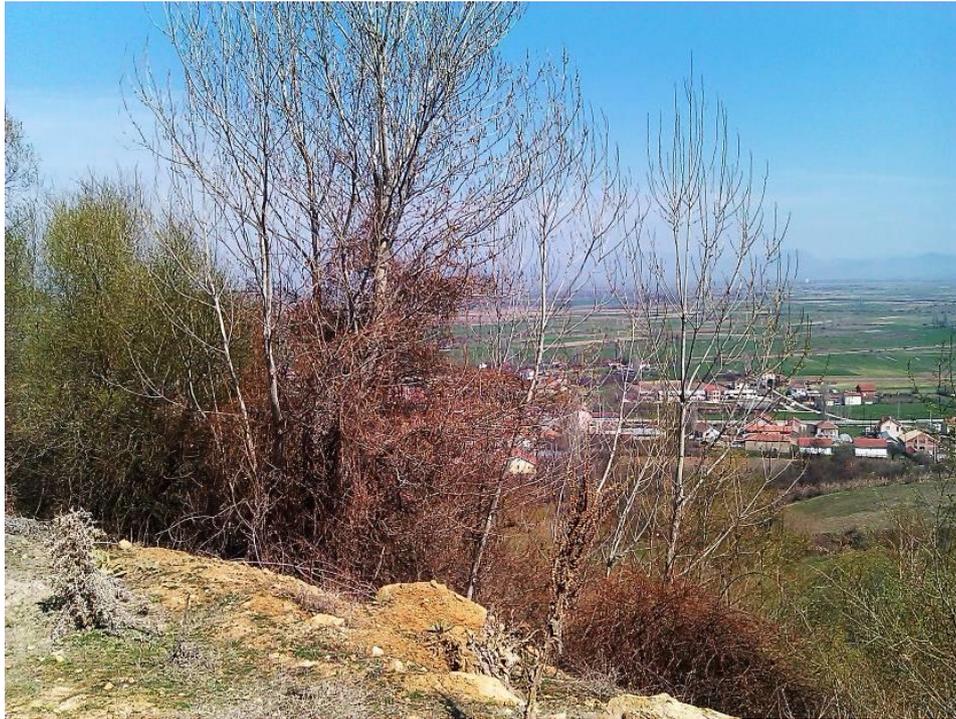
Figure 21. "Drunk forest" (source: photographed 29.03.2012)

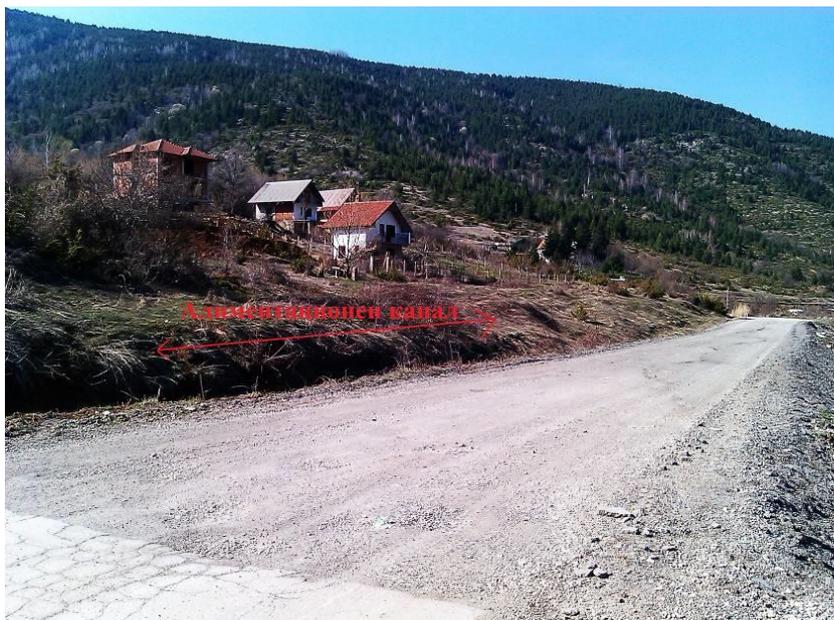
Figure 24. Location of the alimentation channel in relation to the road Bitola - Nidze Pole (source: photographed 29.03.2012)

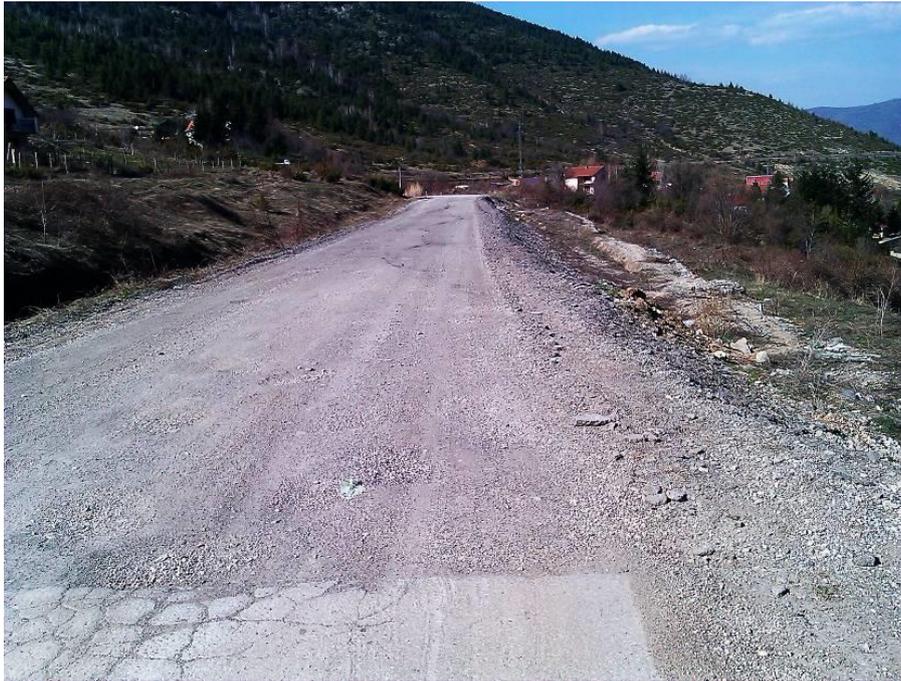
The PE "Strezhevo" has made detailed recordings of the interior of the channel which shows damage to the walls of the channel. During 2011, restoration work was carried out to reinforce the channel plate slab, as well as replacing several roof plates with new serrated plates that cross the upper free ends of the walls.

Figure 25. Cracks along the axis of the road Bitola - Nidze Pole (source: photographed 29.03.2012)

A Basic Rehabilitation design has been developed for this landslide, but the measures provided for the solution have not yet been applied.

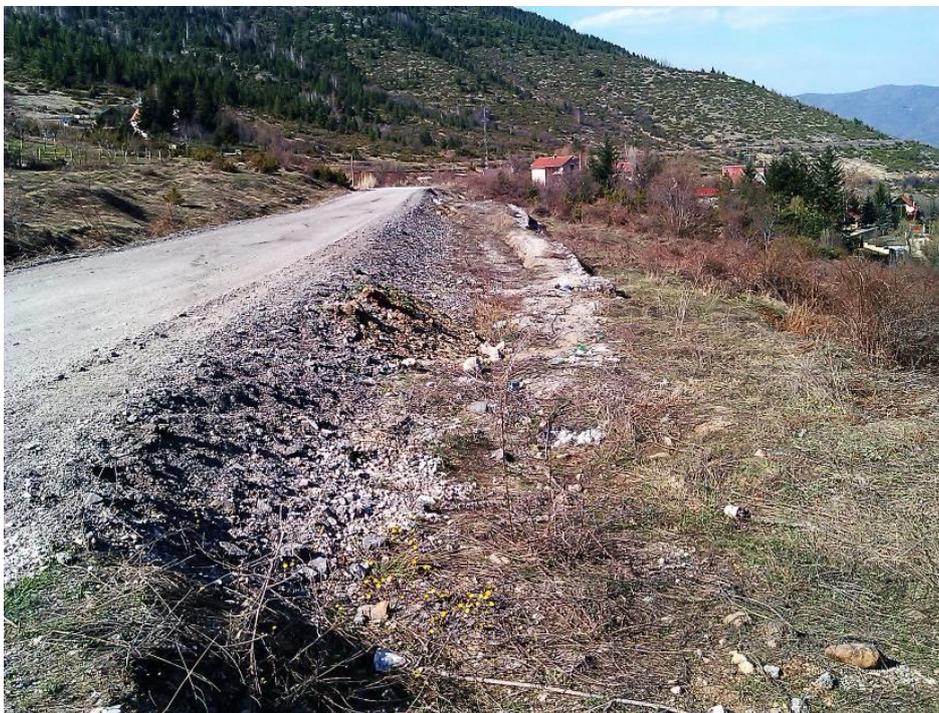
Figure 26. Location of support structure of gabions under the road Bitola - Nidze Pole (source: photographed 29.03.2012)

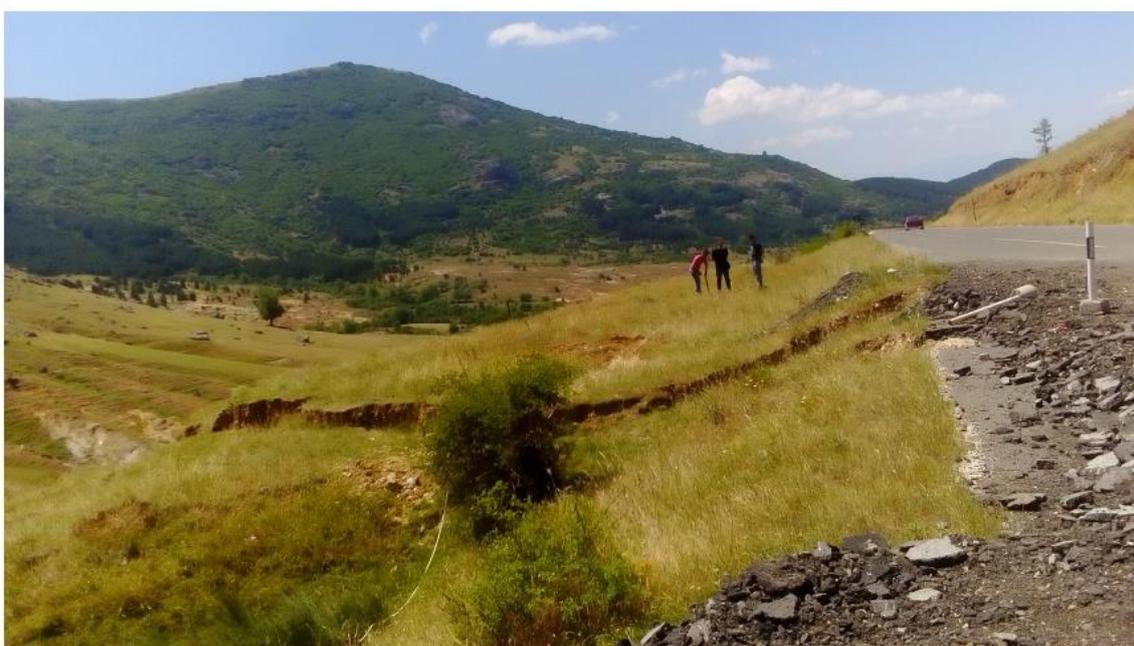
These two landslides are developed within metamorphic rocks of gneiss or graphite schist. Figure 28 shows their position on the Basic Geological Map of the Republic of North Macedonia in a scale of 1: 100 000. Their occurrence was more clearly defined in 2015, when appropriate geotechnical investigations were undertaken.

Figure 29. Landslide area just below the road at km 35 + 000

Basic reparation designs have been developed for these occurrences, but the measures provided as a solution have not yet been applied.

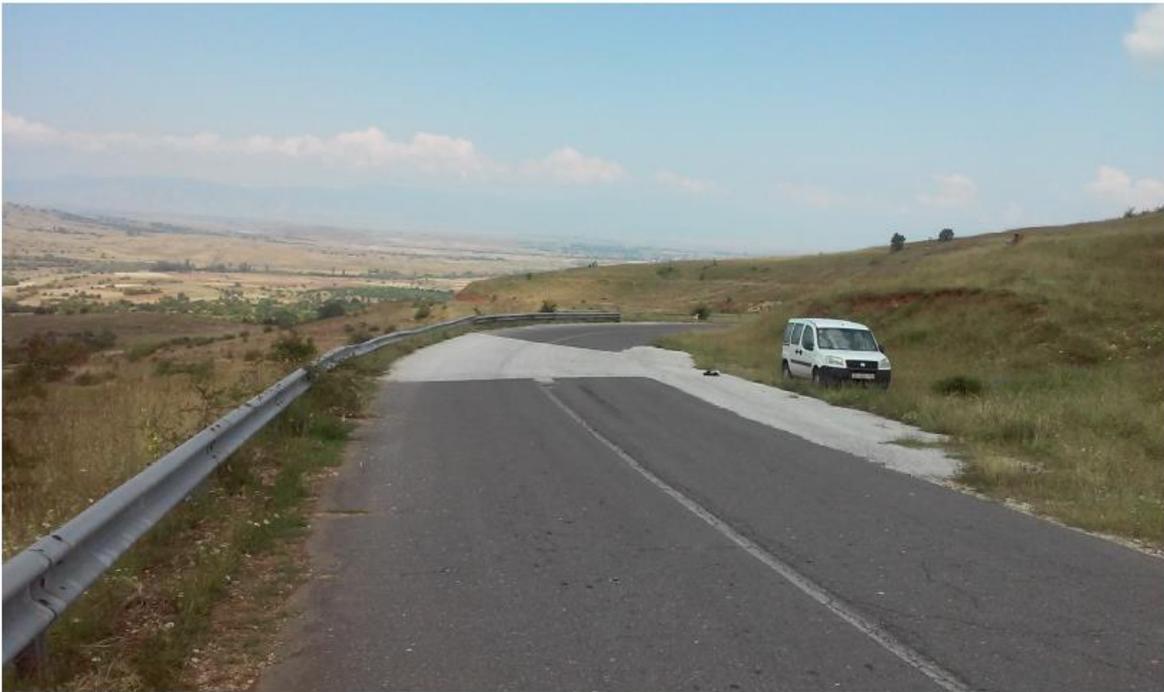
Figure 30. Landslide area adjacent to km 34 + 500

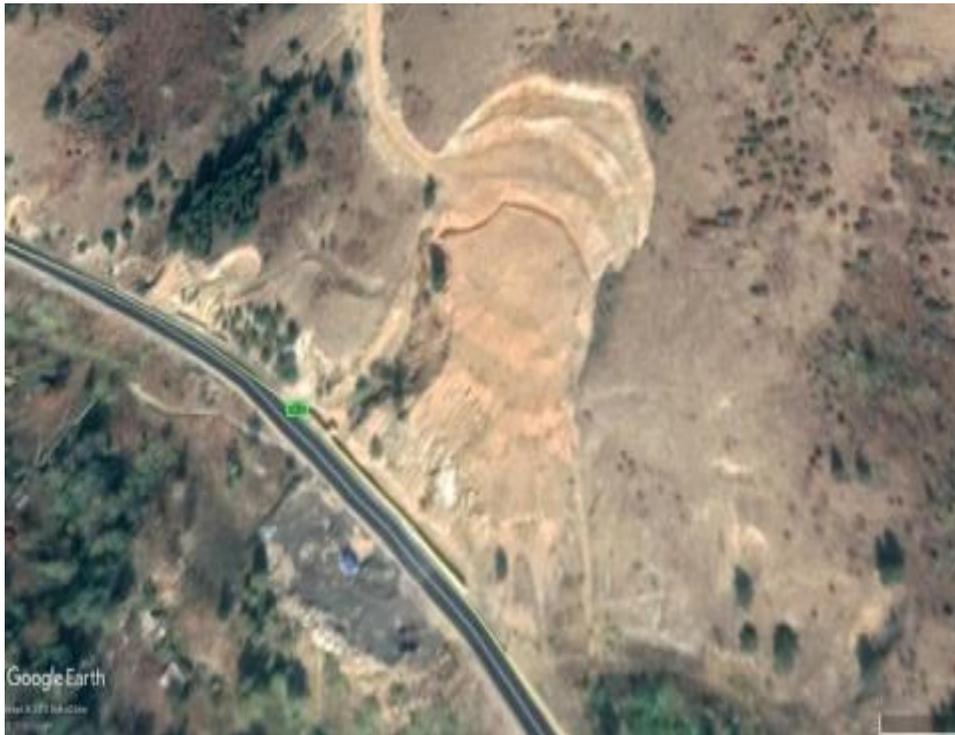
From a geological point of view, masses that are affected by landslides and dislocations are fragments of deluvial quaternary sediments, together with part of decomposed metamorphic and magmatic rocks. According to the findings, a technical solution for remediation was developed in 2015 by the company Civil Engineering Institute of North Macedonia-Skopje. The position of landslides is shown in Figure 31.

Figure 31. Google Earth snapshot of the Bitola bypass landslides (the smaller area to the left is visible, while the larger landslide is clearly visible in the center)

It should be mentioned that these landslides are already repaired.

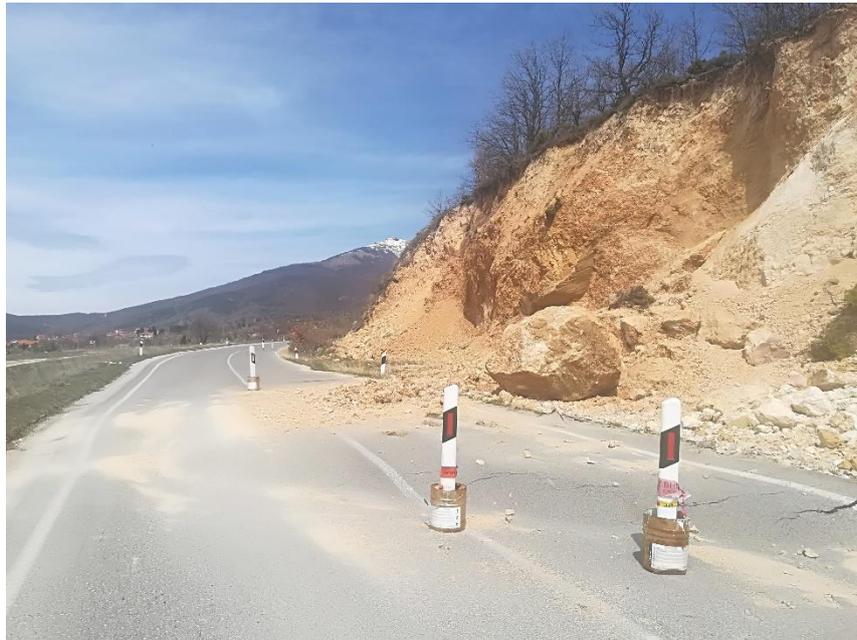
This landslide occurred during 2017. From the geological point of view, the terrain masses affected by the landslide represent altered fractured parts of the granite masses, which have caused deformations of the road and redirection of traffic for almost a year (Figure 34).

Figure 34. Photo of landslide on Pretor-Markova Noga road

According to the findings, a technical solution for repair has been developed and is in the process of being tendered for construction.
